ACOUSTIC MONITOR CUTS COST OF MACHINING EXOTIC ALLOY

Sliding-head lathe's £4,000 retrofit pays for itself in 10 weeks

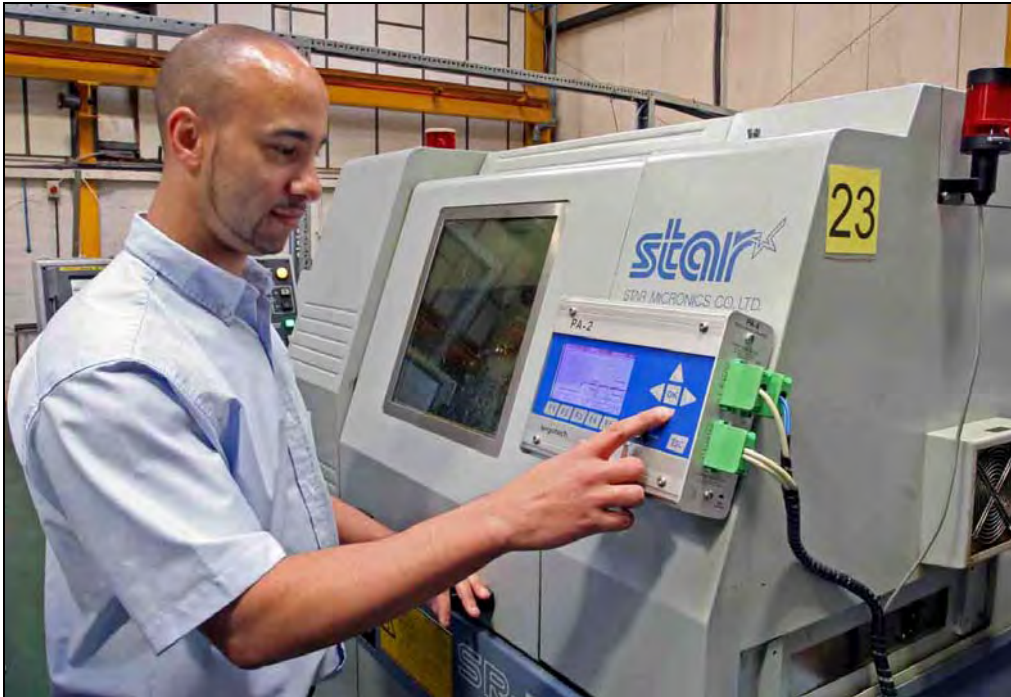
Leroy Lippett, MSP's engineering manager, operating the Argotech PA-2.

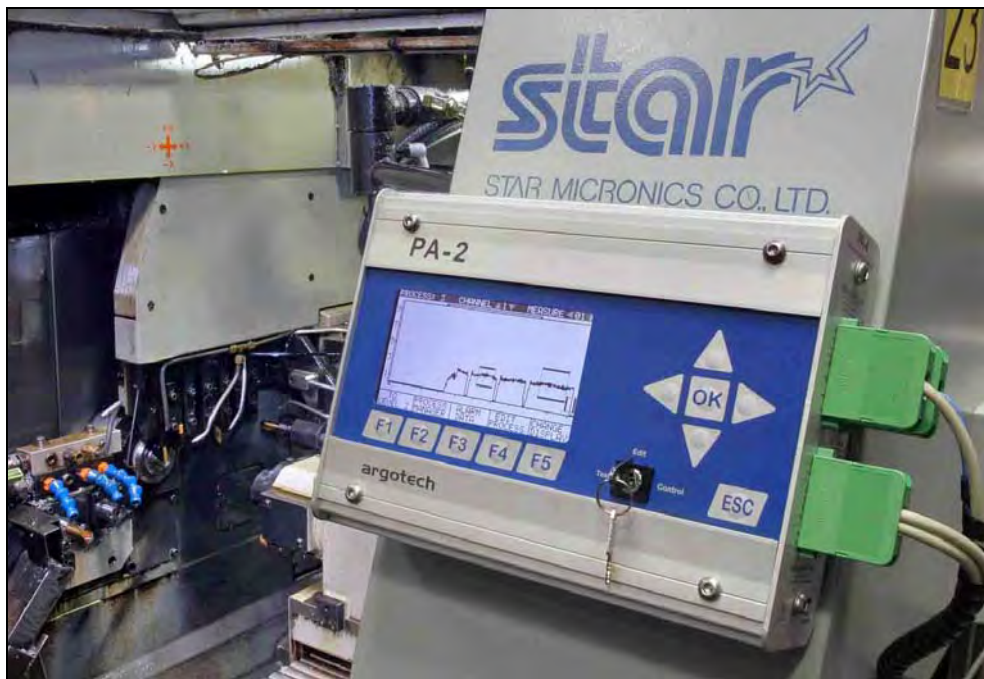
Close-up showing the acoustic fingerprint of an ideal peck cycle for drilling a Hastelloy C-276 sensor component. Boundary boxes where sound presence is mandatory can be seen superimposed on the trace.

Commented Leroy Lippett, MSP's engineering manager, "Setting up acoustic monitoring is very straightforward. We ran a peck drilling cycle on a component using a new tool and recorded an ideal acoustic profile on the screen of the PA-2.

"We then drew boundary boxes at strategic points along the trace where it is essential for the drill to be present. These are on the second peck to make sure that the drill did not break during entry, on the last peck to verify that the hole is completely machined and on retraction to warn if the drill breaks on the way out.

"When the drill does eventually break, the lower threshold of one of the boundary boxes detects the absence of sound and the lathe is stopped instantly.

“Alternatively, the same boundary box detects when the noise from the drilling operation increases beyond the upper threshold and similarly stops the machine to avert tool breakage and allow its early replacement.”

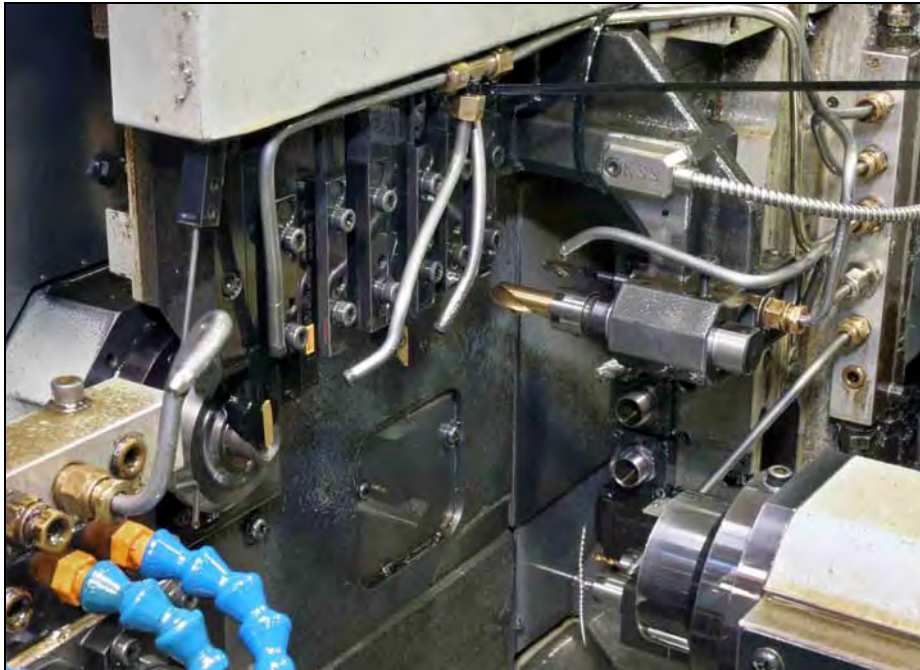
The Argotech acoustic sensor is seen here fitted to the Star lathe platen above the endworking drill. All tools on the platen, including the gang tooling, can be monitored for sound output during machining.

The acoustic sensor is clamped to the sliding-head lathe's tool platen, which carries the endworking drill. It is this close mechanical link between tool and monitor on a sliding-head lathe that allows sound to be detected with such precision.

This sensor was found to be the most sensitive and accurate at recognising that the small-diameter drill was no longer cutting at any

point during the pecking cycle, signifying that the tool was broken. It also allows drill replacement before breakage, provided that the tool wears predictably rather than failing suddenly.

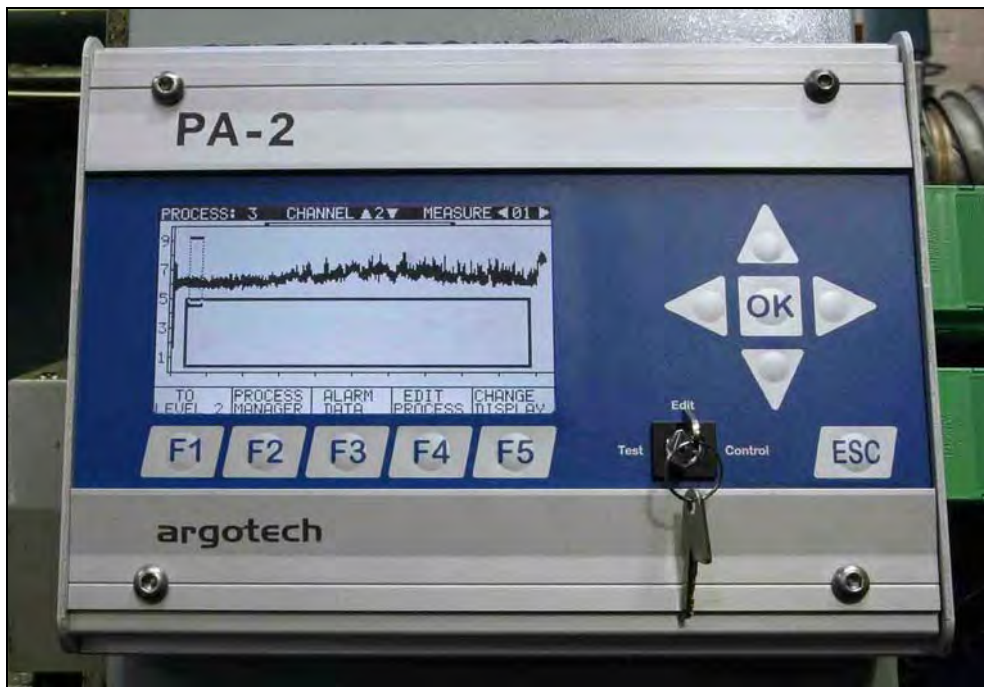
MSP is also experimenting with using the PA-2's spindle power sensor to control other machining operations. The above trace shows a typical output display.

The spindle power sensor is used to monitor tooling not associated with the tool platen.
